Movement of Tagged Dredged Sand at Thalweg Disposal Sites in the Upper Mississippi River

Volume 3:
Additional Results at Gordon's Ferry
and Whitney Island Sites

ANL/EES-TM-270, Vol. 3

April 1985

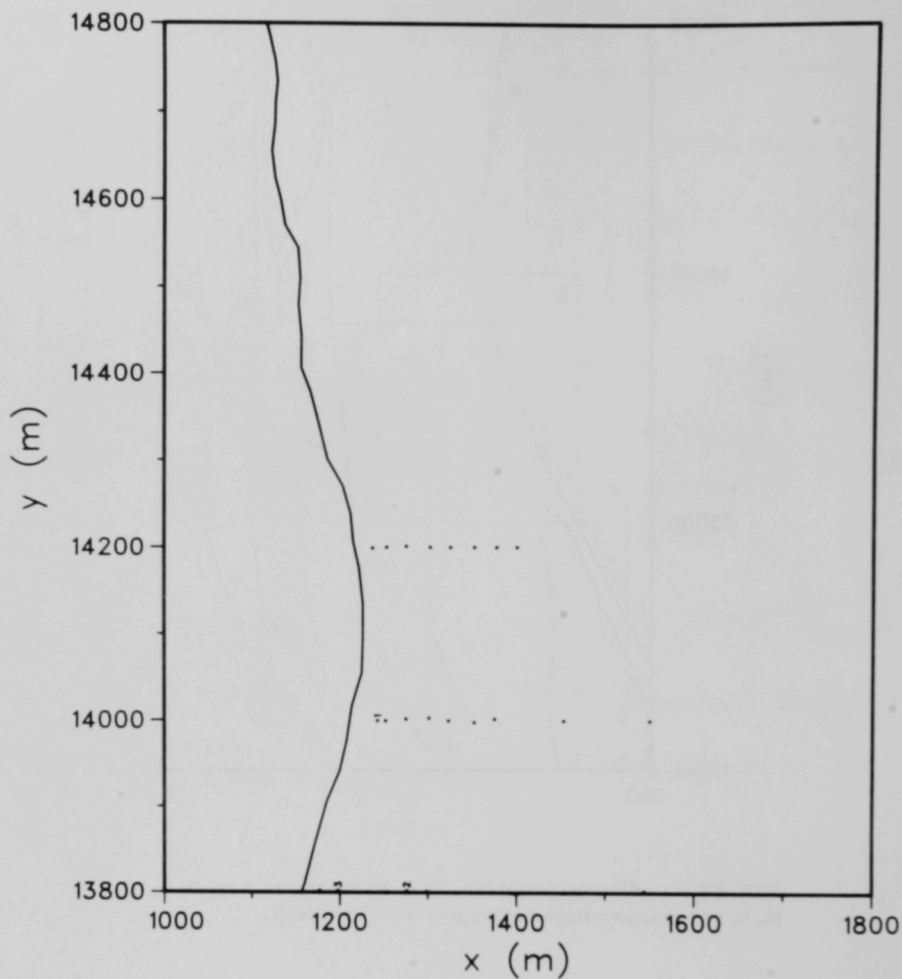
FIGURE B.5 Bottom Sampling Locations and Dyed Sand Counts in Region a of the Whitney Island Site for Survey VI

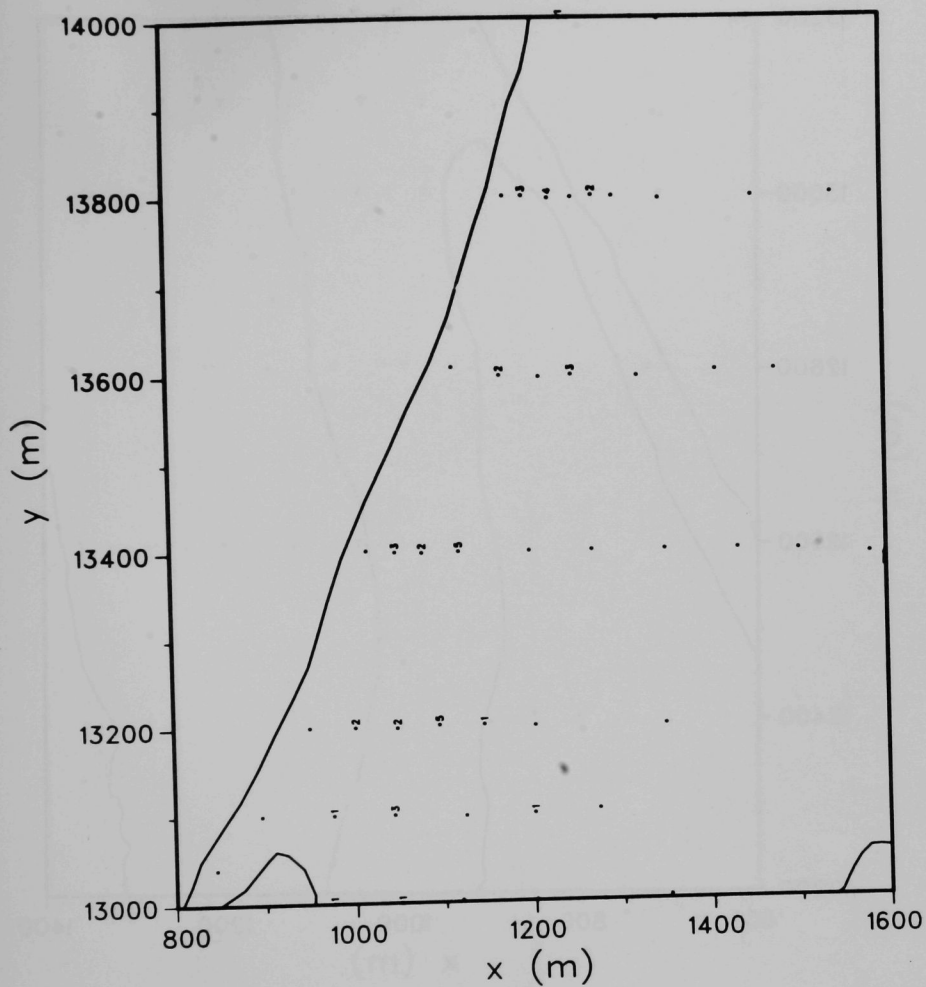
FIGURE B.6 Bottom Sampling Locations and Dyed Sand Counts in Region b of the Whitney Island Site for Survey VI

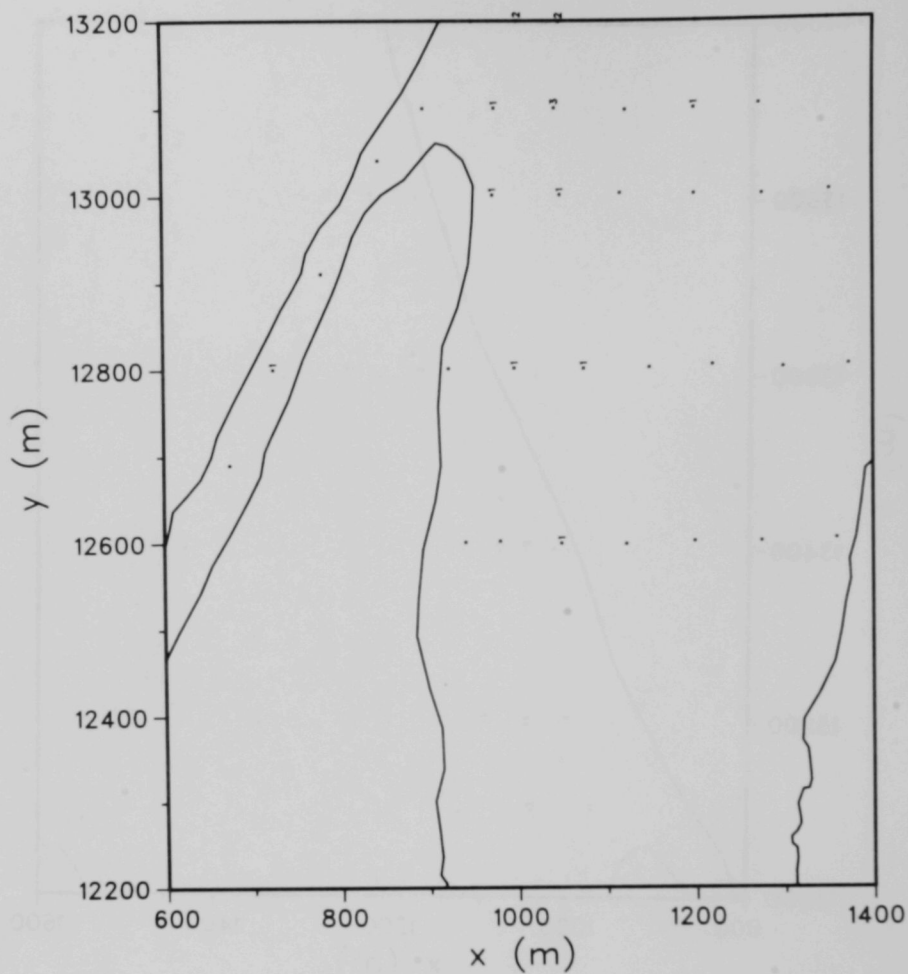
FIGURE B.7 Bottom Sampling Locations and Dyed Sand Counts in Region c of the Whitney Island Site for Survey VI

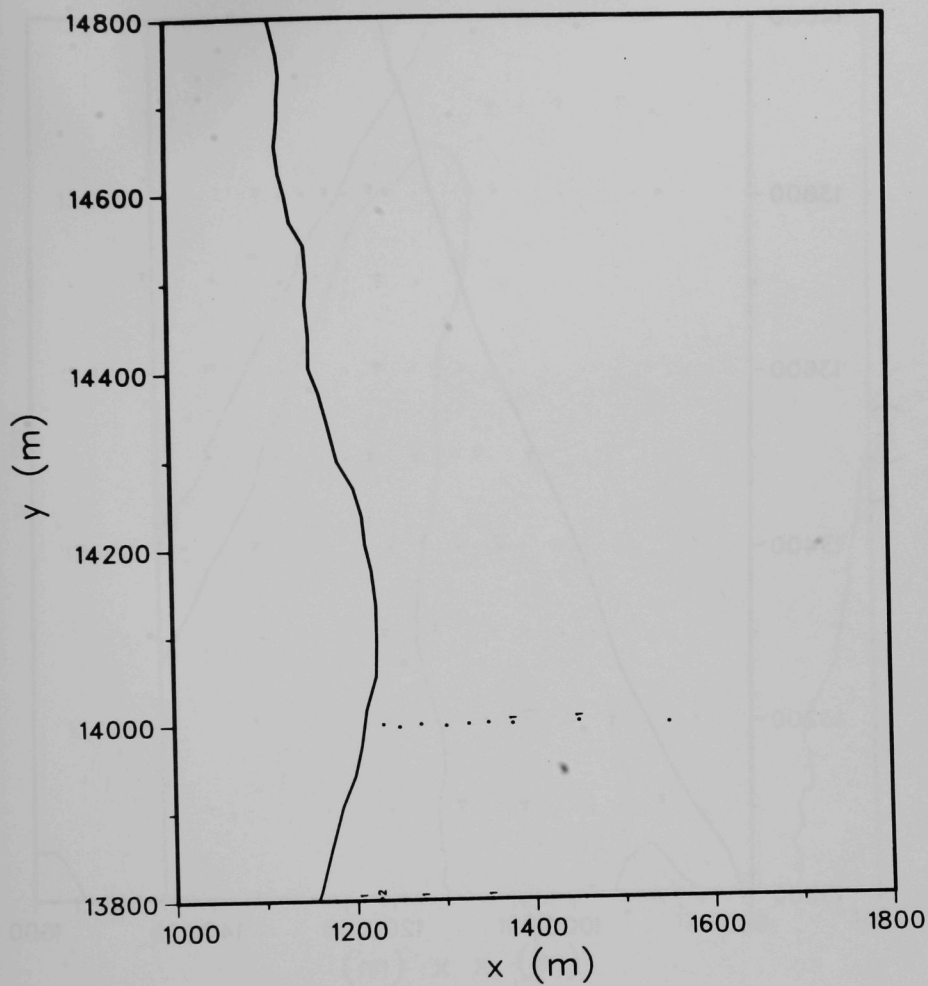
FIGURE B.8 Bottom Sampling Locations and Dyed Sand Counts in Region a of the Whitney Island Site for Survey VII

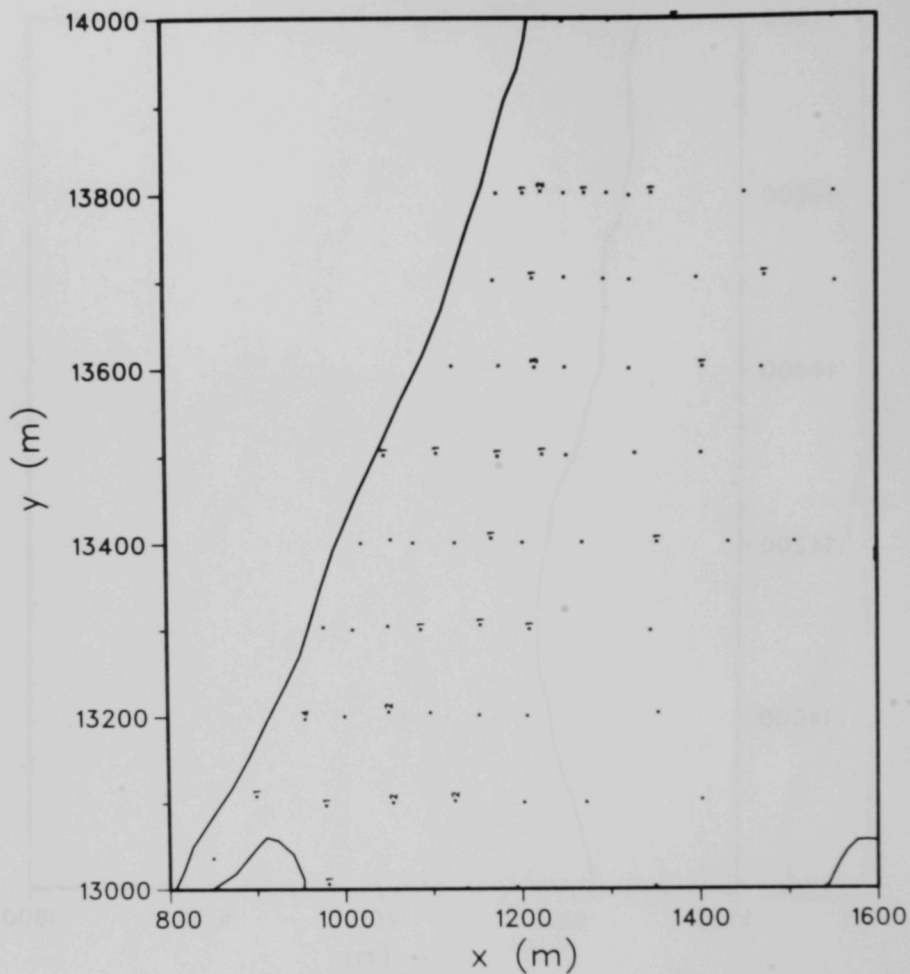
FIGURE B.9 Bottom Sampling Locations and Dyed Sand Counts in Region b of the Whitney Island Site for Survey VII

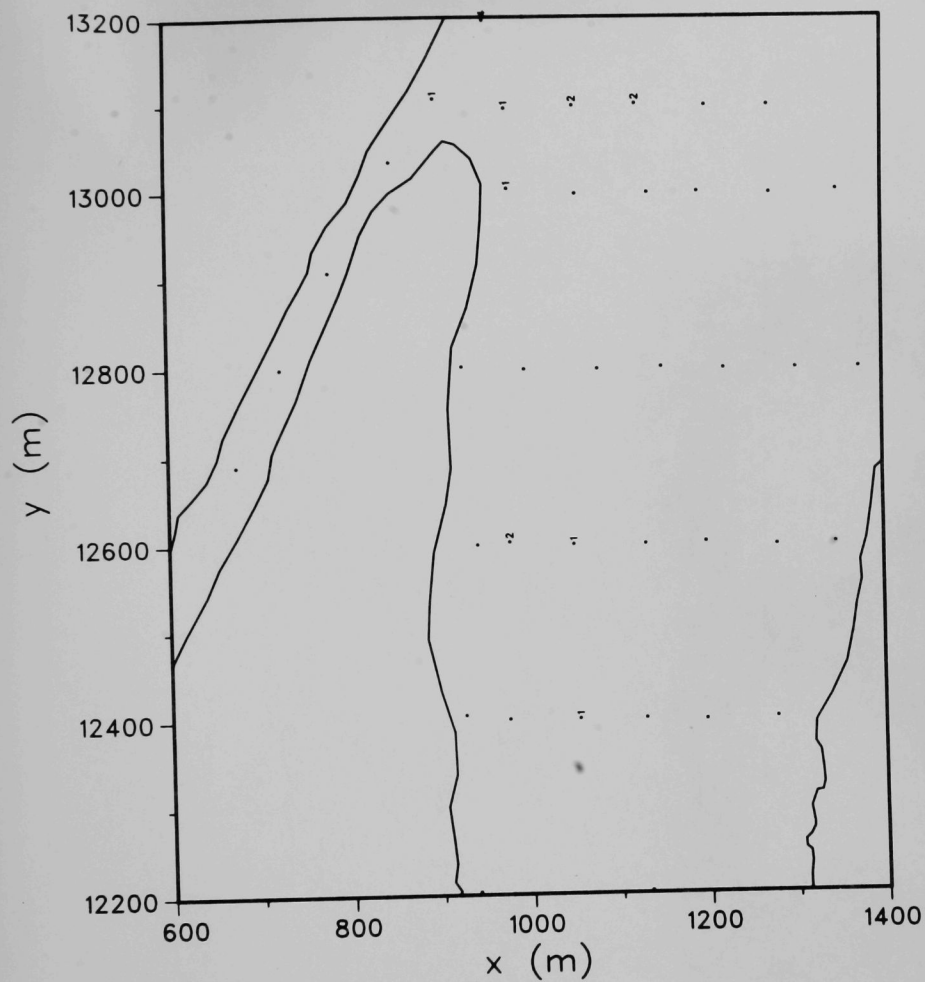
FIGURE B.10 Bottom Sampling Locations and Dyed Sand Counts in Region c of the Whitney Island Site for Survey VII
